REPORT NO. RD-64-46

EVALUATION
OF
TAXIWAY CENTERLINE LIGHTING

FEDERAL AVIATION AGENCY

Systems Research & Development Service

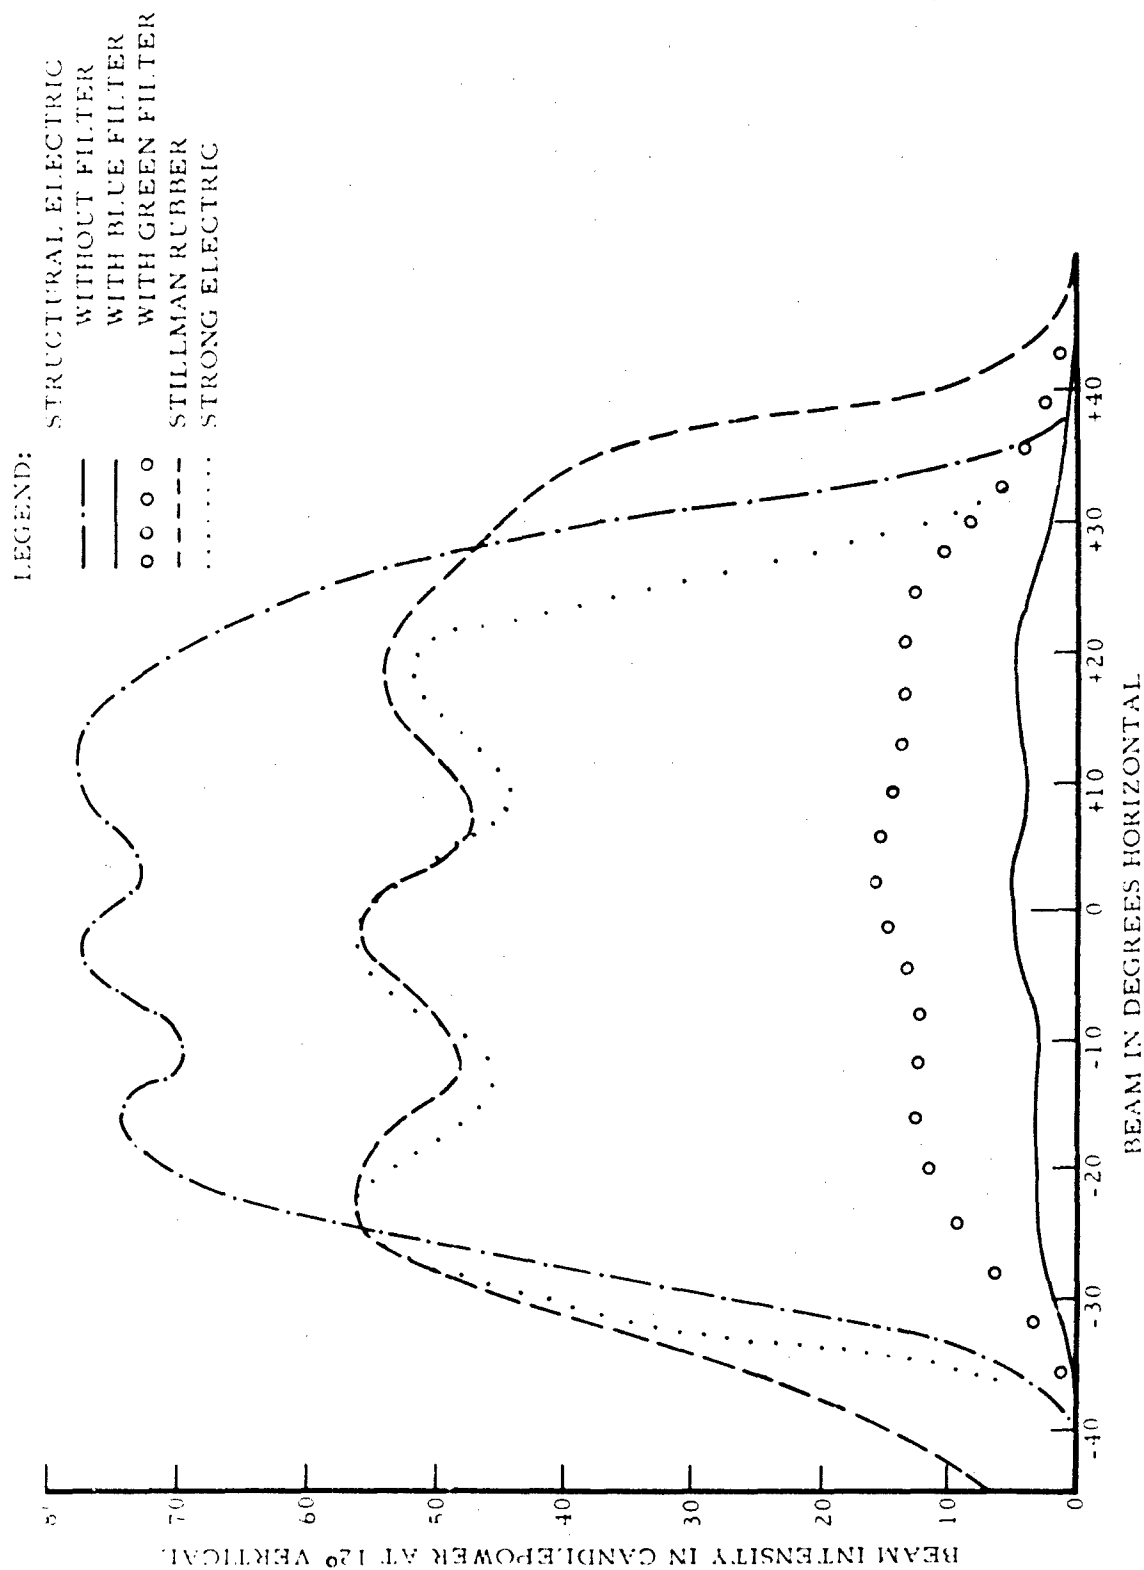
FIG. 18 PHOTOMETRIC DATA ON STRUCTURAL ELECTRIC PRODUCTS CORPORATION, STRONG ELECTRIC CORPORATION, AND STILLMAN RUBBER COMPANY FIXTURES

Filters: When blue or green filters were installed in the fixtures, the intensity of light output decreased approximately 80 percent for green and

96 percent for blue (FIG. 18). Observations of the filtered light during daylight hours revealed that the intensity of both blue and green lights was inadequate for daylight use.

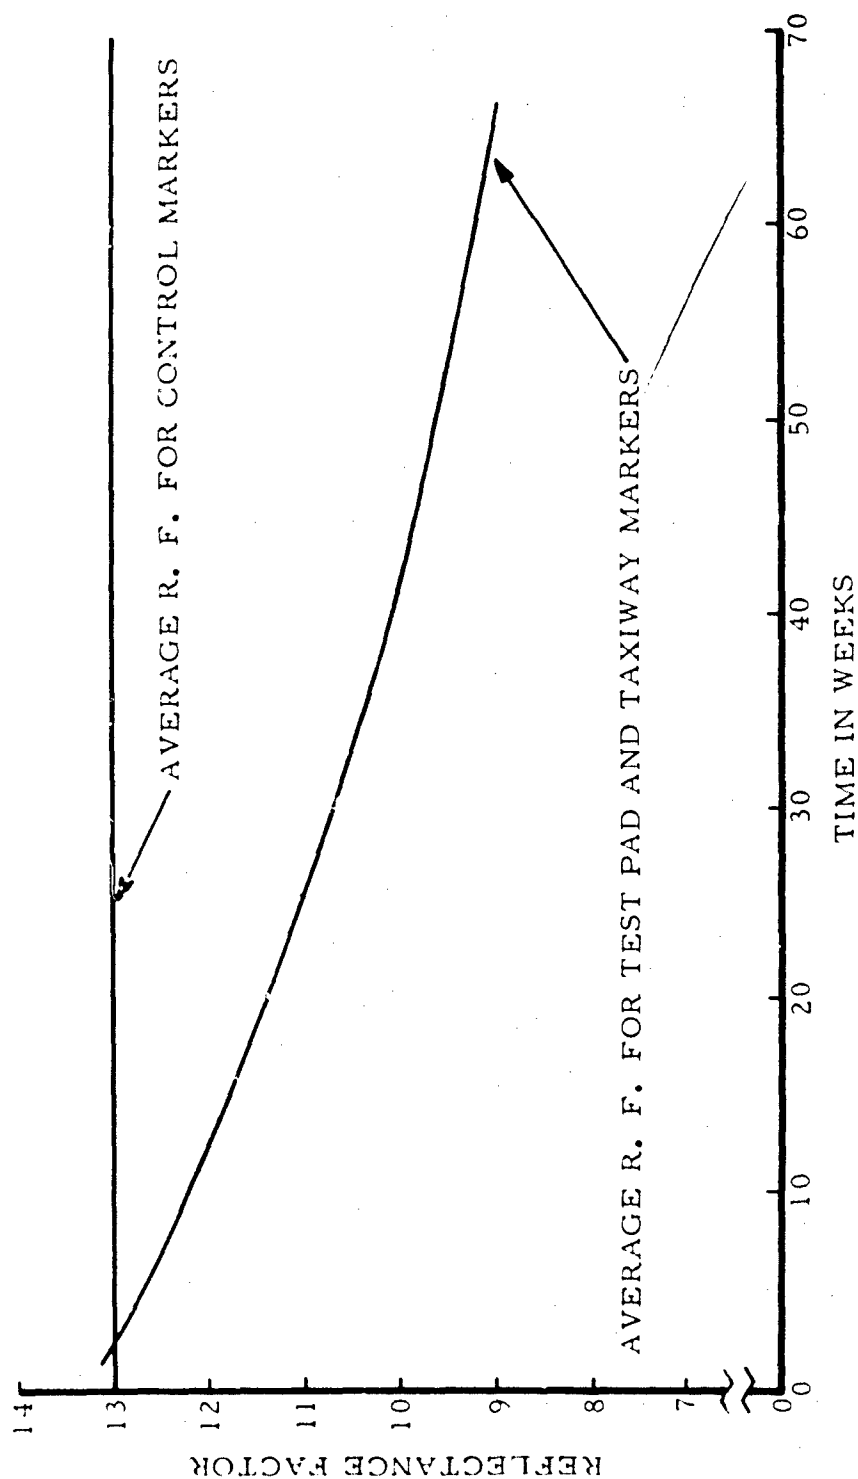
$$\text{REFLECTANCE FACTOR} = \frac{\text{BRIGHTNESS (FOOT LAMBERTS)}}{\text{ILLUMINATION (FOOT CANDLES)}}$$

Figure 19 compares the reflectance factors of new (control) and installed reflective markers over a period of sixty-six weeks.

Any variation in reflectance factor with time was caused by variations in environmental conditions, i.e., dust on the reflector in dry periods and partial cleaning of the reflector by rain or wind. Data were taken to obtain a comparison of reflectance factors between dry and damp reflectors. This comparison indicated very little difference in reflectance factor.

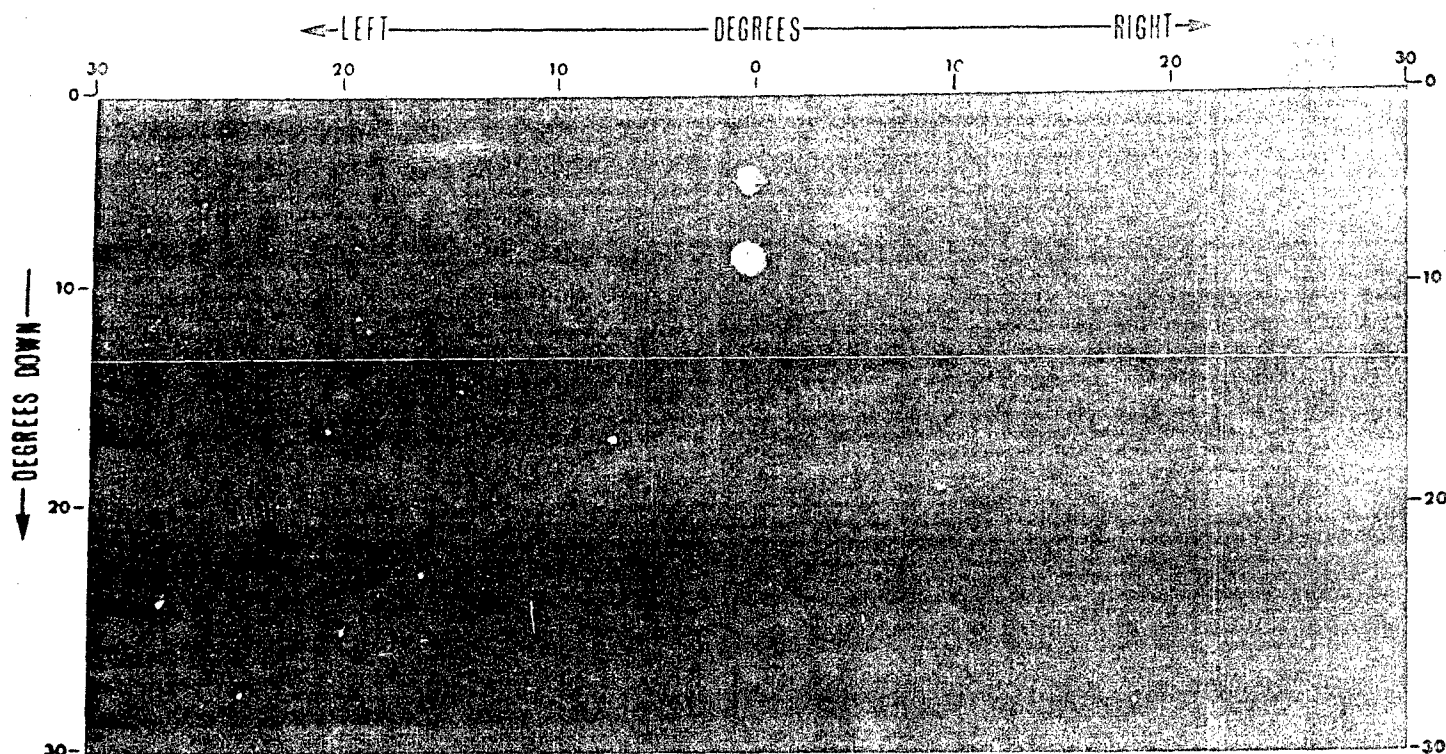
FIG. 20 PERSPECTIVE DIAGRAM. STRAIGHT TAXIWAY, TCLV 200 FEET AND CENTERLINE LIGHTS SPACED 100 FEET APART. GUIDANCE INADEQUATE.

Figure 20 illustrates what is seen when the lights are spaced 100 feet apart. The pilots rated this as inadequate guidance. Figure 21 illustrates what is seen when the lights are spaced 50 feet apart. The pilots rated this as adequate guidance.

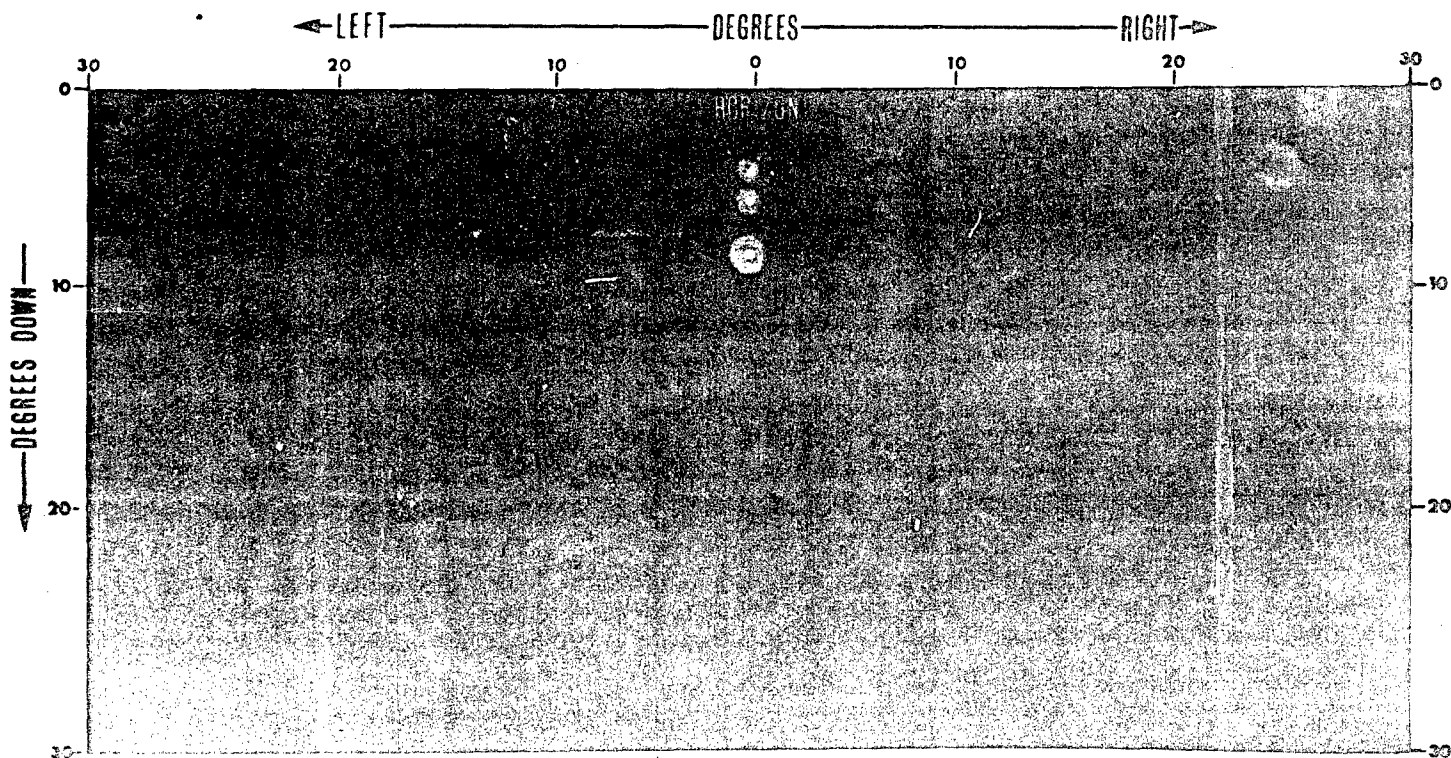
FIG. 21 PERSPECTIVE DIAGRAM. STRAIGHT TAXIWAY, TCLV 200 FEET, AND CENTERLINE LIGHTS SPACED 50 FEET APART. GUIDANCE ADEQUATE.

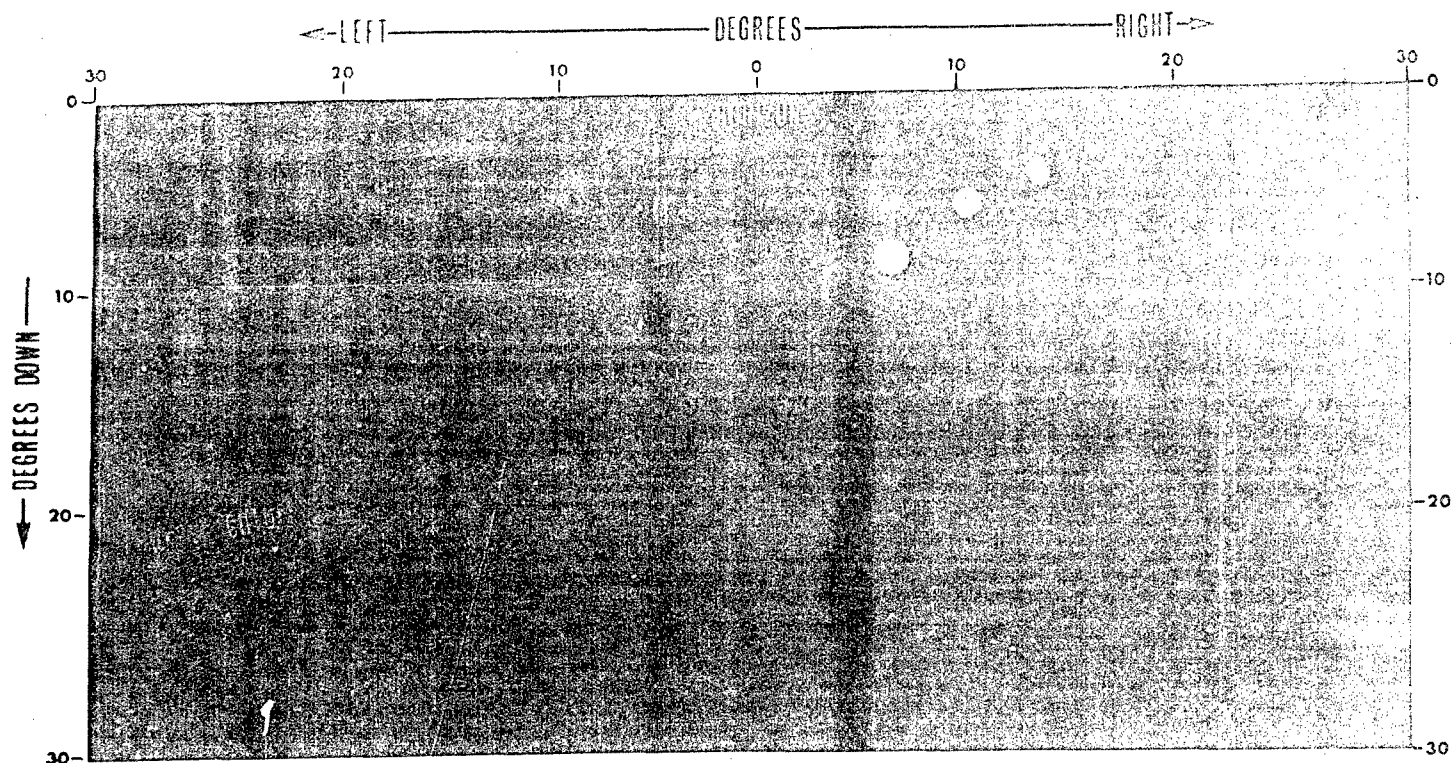
FIG. 22 PERSPECTIVE DIAGRAM. 1280 FOOT RADIUS CURVE, TCLV 200 FEET, AND CENTERLINE LIGHTS SPACED 50 FEET APART. GUIDANCE INADEQUATE.

Figures 22 and 23 illustrate the pilots' view of a curved taxiway which has a centerline radius of 1280 feet. In Figure 22, the lights are spaced 50 feet apart. The pilots rated the guidance received as inadequate. Figure 23 is the same as Figure 22 except that the lights are spaced 25 feet apart. The pilots rated the 25-foot spacing as adequate.

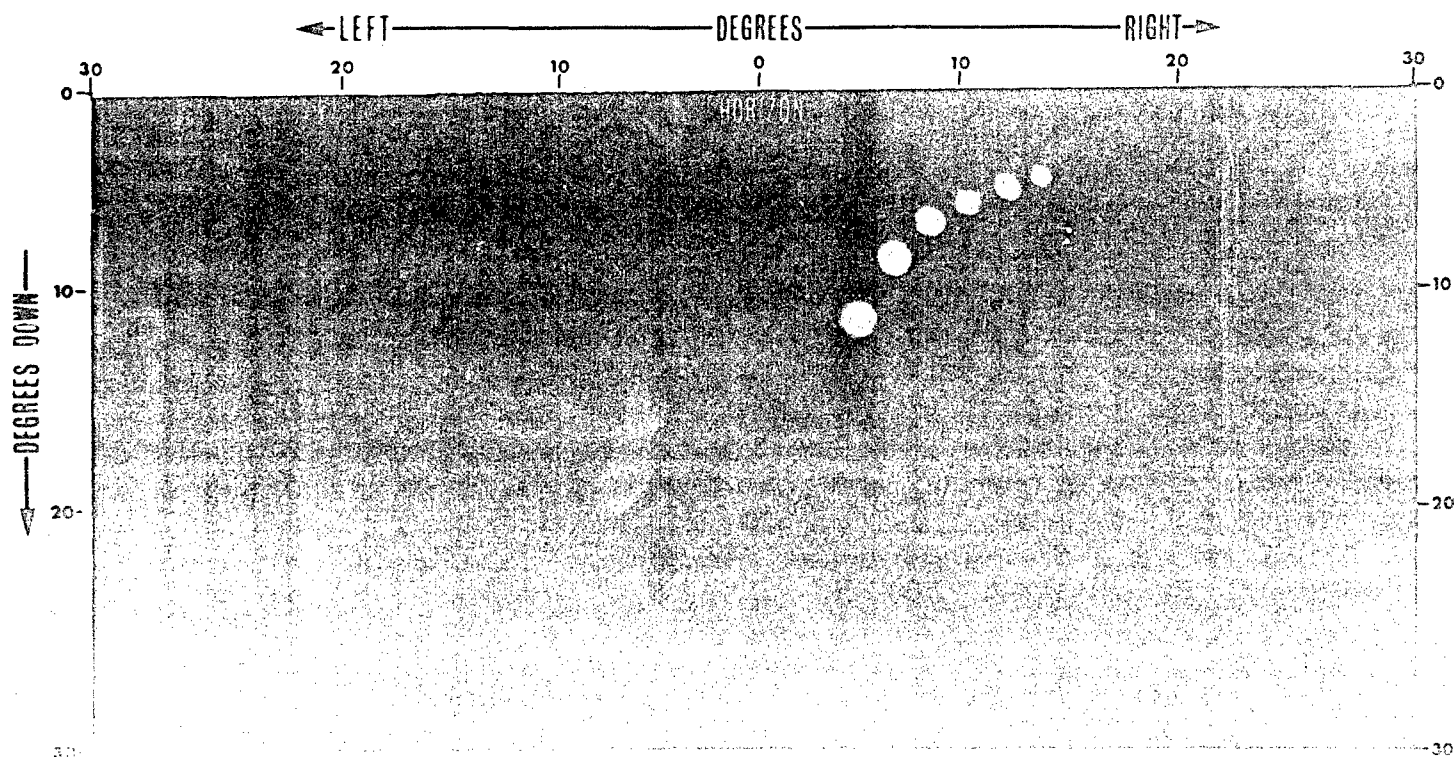
FIG. 23 PERSPECTIVE DIAGRAM. 1280 FOOT RADIUS CURVE, TCLV 200 FEET, AND CENTERLINE LIGHTS SPACED 25 FEET APART. GUIDANCE ADEQUATE.

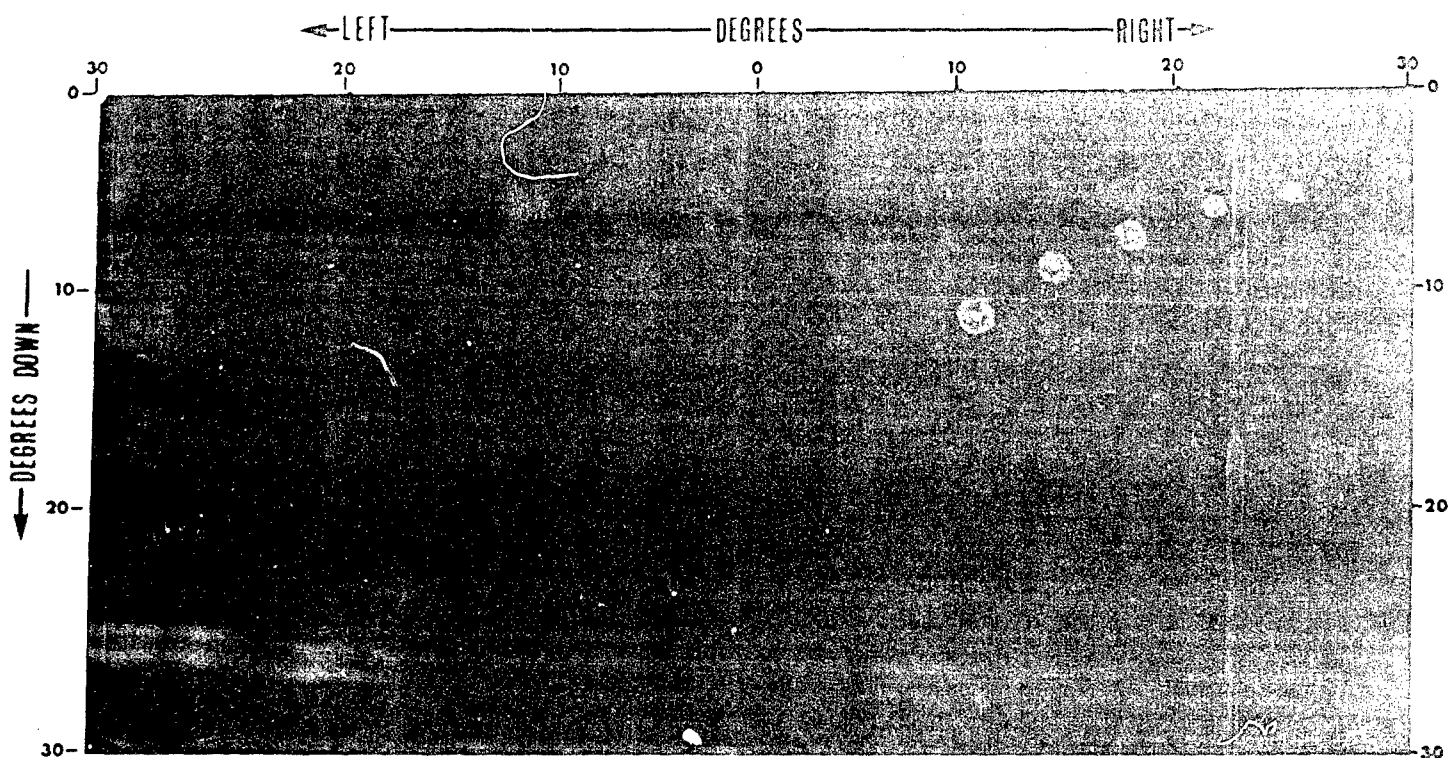
FIG. 24 PERSPECTIVE DIAGRAM. 200 FOOT RADIUS CURVE, TCLV 200 FEET, AND CENTERLINE LIGHTS SPACED 25 FEET APART. GUIDANCE INADEQUATE.

Figures 24 and 25 illustrate the pilots' view of a curved taxiway which has a centerline radius of 200 feet. In Figure 24, the lights are spaced 25 feet apart, and the pilots rated the guidance received as inadequate. Figure 25 illustrates the same curve as Figure 24 except that the lights are spaced 12.5 feet apart. The pilots rated the 12.5 foot spacing as adequate. Again, the 10-degree cone contained less than four lights when the guidance was rated inadequate, and four or more lights when the guidance was rated adequate.

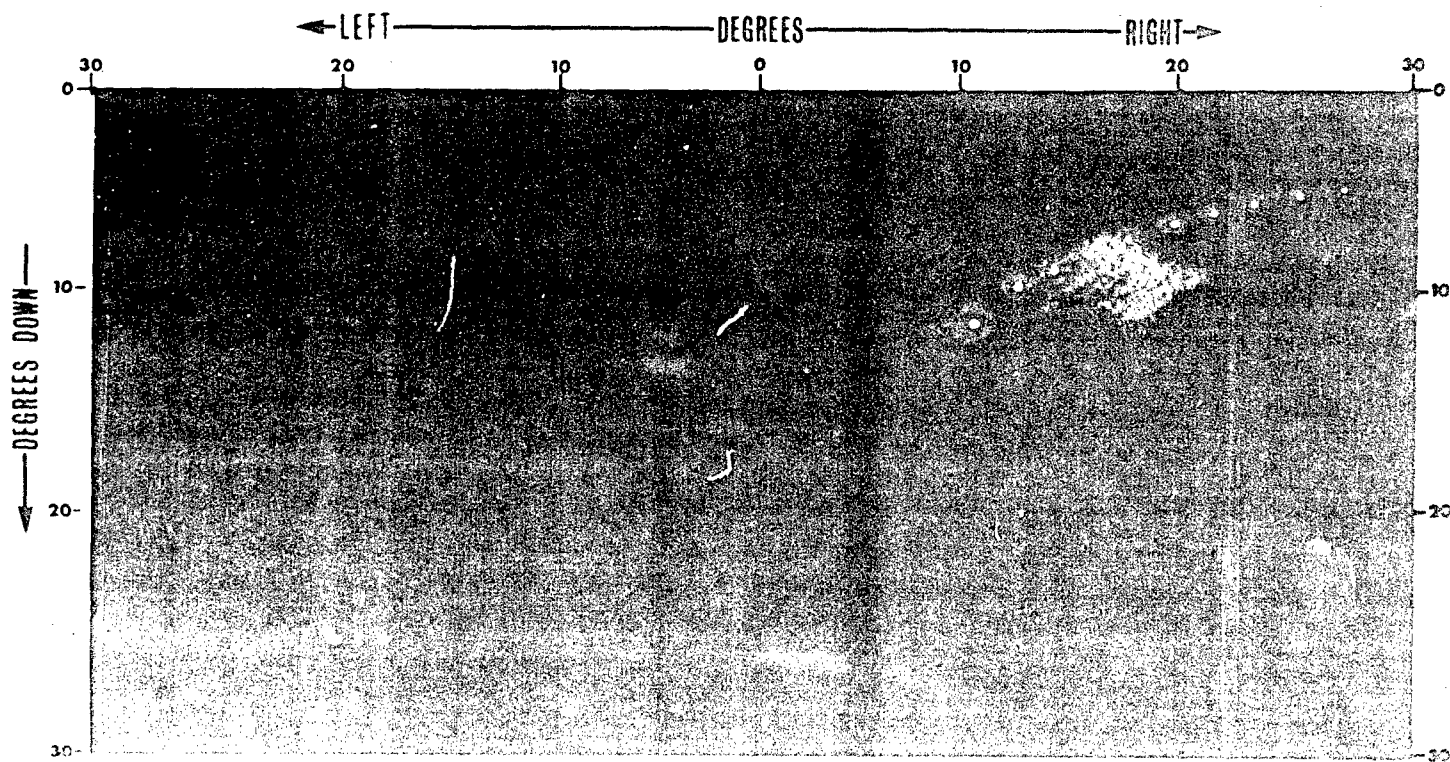
FIG. 25 PERSPECTIVE DIAGRAM. 200 FOOT RADIUS CURVE, TCLV 200 FEET, AND CENTERLINE LIGHTS SPACED 12.5 FEET APART. GUIDANCE ADEQUATE.

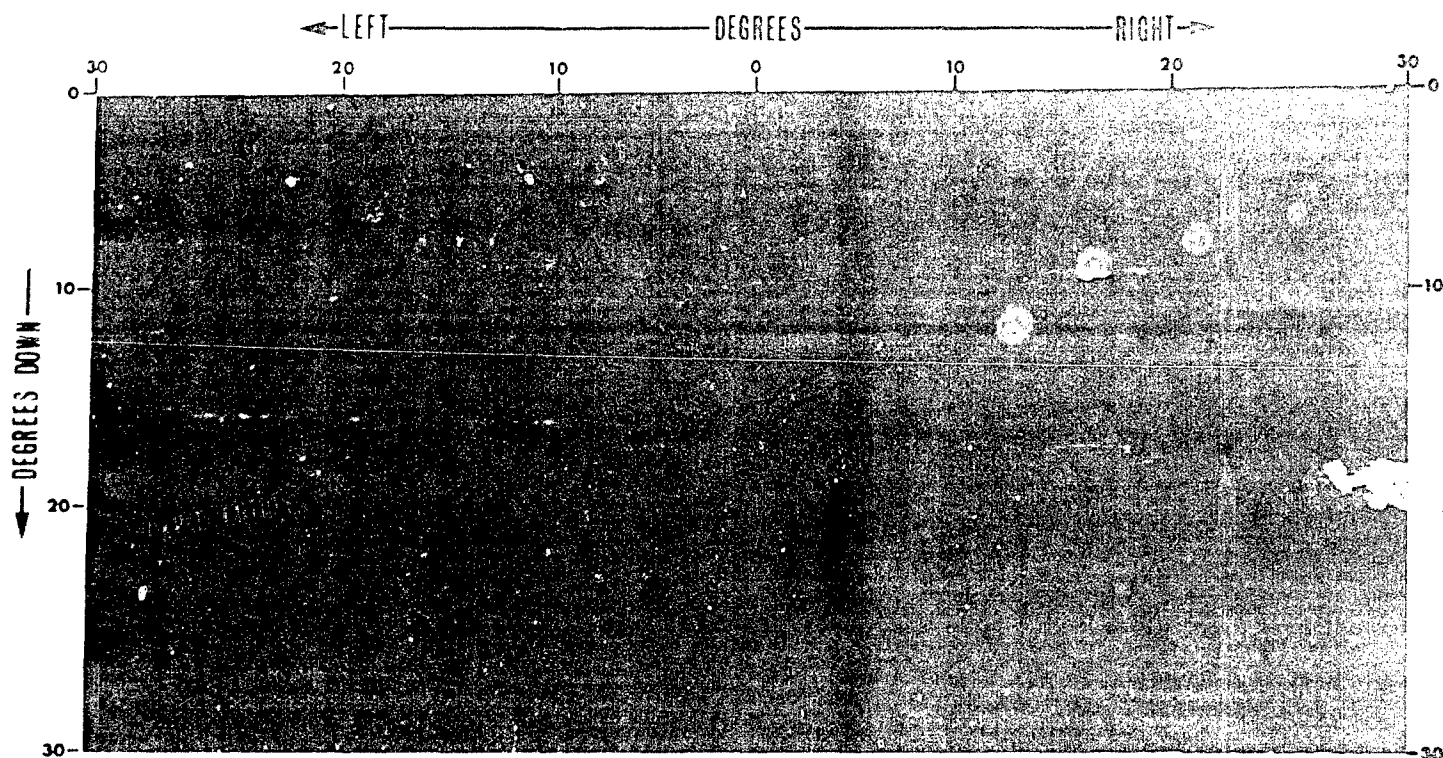
FIG. 26 PERSPECTIVE DIAGRAM. 165 FOOT RADIUS CURVE, TCLV 200 FEET, AND CENTERLINE LIGHTS SPACED 25 FEET APART. GUIDANCE INADEQUATE.

Figures 26 and 27 illustrate the pilots' view of a curved taxiway that has a centerline radius of 165 feet. When the lights were spaced 25 feet apart (FIG. 26) the pilots rated the guidance as inadequate, and when the lights were spaced 12.5 feet apart (FIG. 27) the pilots still rated the guidance as inadequate.

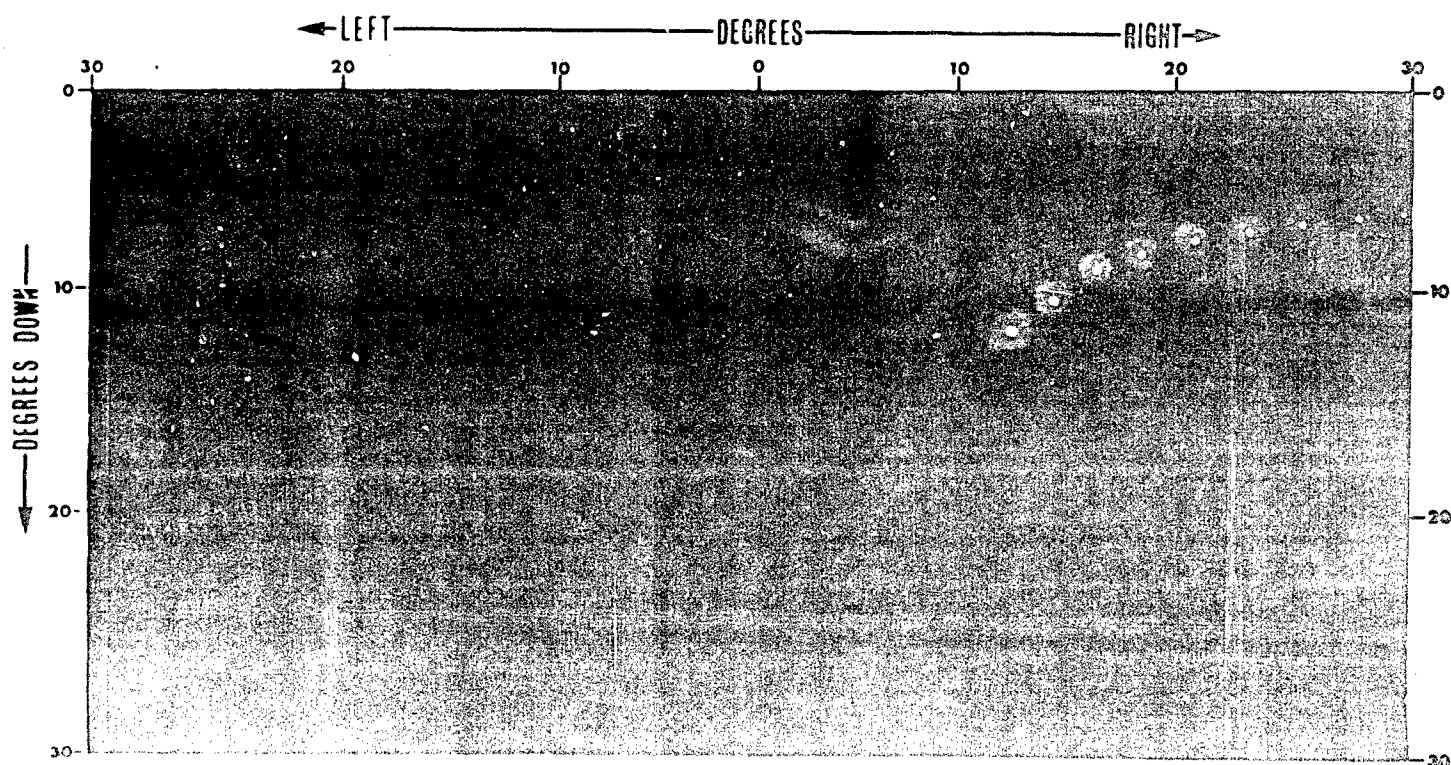
FIG. 27 PERSPECTIVE DIAGRAM. 165 FOOT RADIUS CURVE, TCLV 200 FEET, AND CENTERLINE LIGHTS SPACED 12.5 FEET APART. GUIDANCE ADEQUATE.

The apparent inconsistency between the results from the pilots' ratings (Table VII) and the results from the perspective diagrams (FIG. 27) is reasonable since the pilots made their judgments while taxiing a C-131-B aircraft. The C-131-B has a cockpit cutoff approximately five degrees higher than the typical jet transport cutoff selected for the perspective diagrams. This higher cutoff caused the pilot to lean forward and move his head to the left in an attempt to improve his view. Head and body movement improved the angle of view by approximately three degrees.

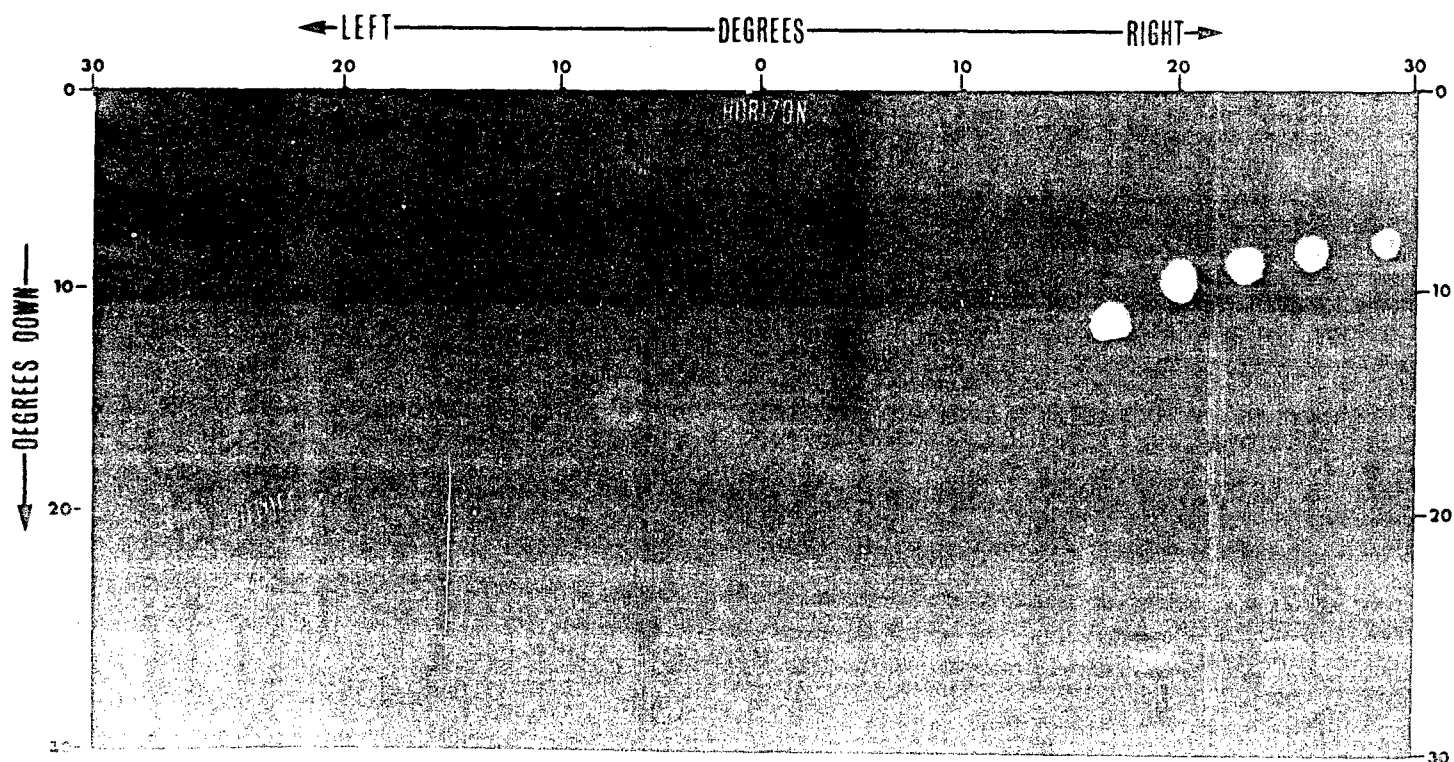
FIG. 29 PERSPECTIVE DIAGRAM. 125 FOOT RADIUS CURVE, TCLV 200 FEET, AND CENTERLINE LIGHTS SPACED 12.5 FEET APART. THEORETICAL GUIDANCE ADEQUATE.

The curves illustrated in Figures 28 and 29 were not available for field testing. However, perspective diagrams were made and the "10-degree cone" theory was applied to the curves. Figure 28 illustrates the pilots' view of a curve with a centerline radius of 115 feet and a light spacing of 12.5 feet, which was rated by the 10-degree cone theory as inadequate. Figure 29 illustrates the pilot's view of a curve with a centerline radius of 125 feet and a light spacing of 12.5 feet. Application of the 10-degree cone theory produced a guidance rating of adequate. It appeared that the 125-foot radius was the minimum usable with aircraft having cockpit cutoff similar to that shown in the perspective diagrams.

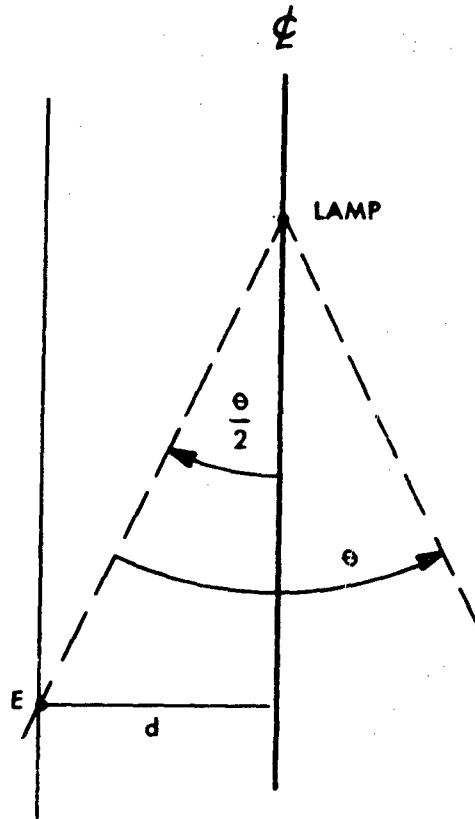
1. The point on the taxiway directly below the pilot's eye (E) remains within five feet of the centerline.
2. Cockpit cutoff characteristics obscure the first 50 feet of the centerline.

CL = centerline

E = point on taxiway directly below pilot's eye

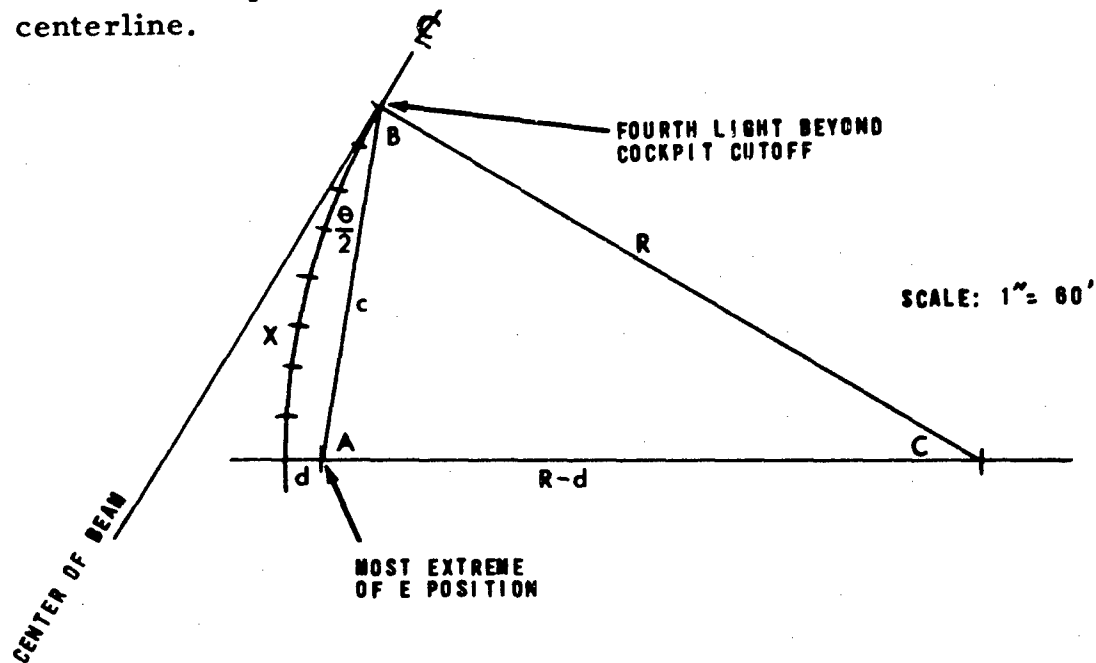
1. The point on the taxiway directly below the pilot's eye (E) remains within 10 feet of the centerline.
2. Cockpit cutoff characteristics obscure the first 50 feet of the centerline.

R = radius of curve

CL = centerline

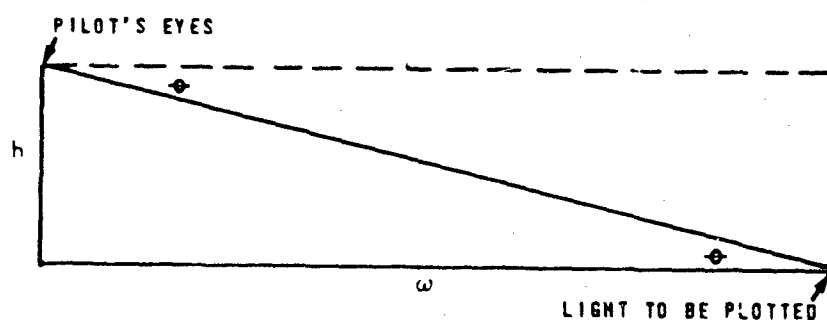
1. Determine the height (h) of the pilot's eyes above ground (15 feet in the example below).
2. Determine the horizontal distance (w) to the light in question (100 feet in the example below).
3. Let ϕ equal the angle of depression.
4. Apply the trigonometric formula $\phi = \tan^{-1} \frac{h}{w}$

$$\begin{aligned}
 h &= 15 \text{ feet} \\
 w &= 100 \text{ feet} \\
 \phi &= \tan^{-1} \frac{15}{100} = \tan^{-1} 0.15 = 8.5^\circ
 \end{aligned}$$

FIG. 5-1. Finding the depression angle (ϕ).

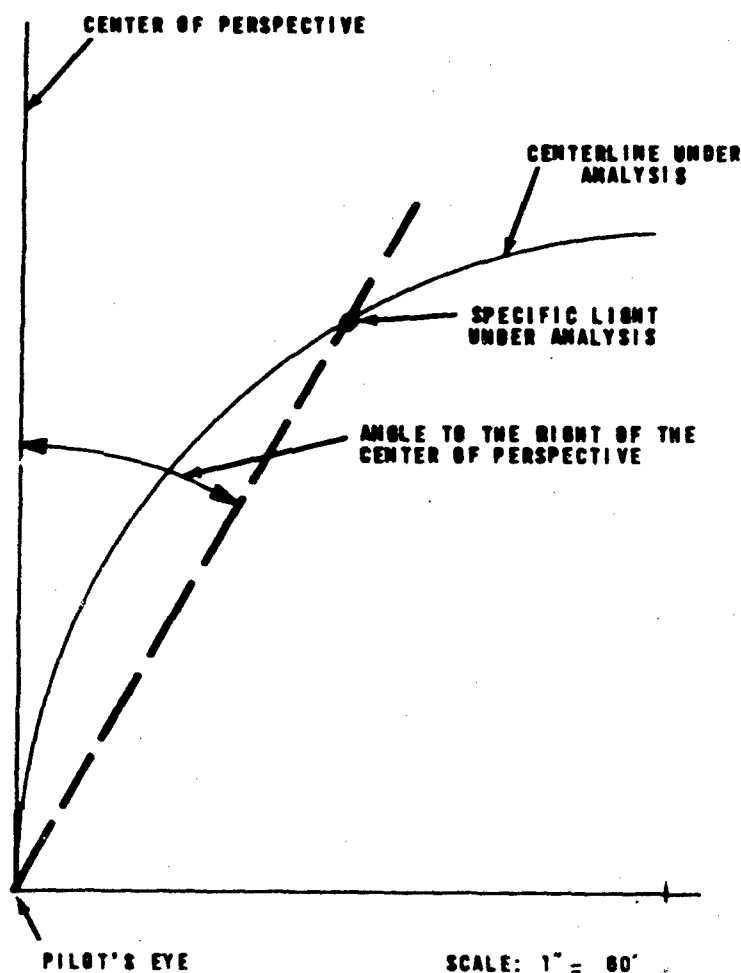
1. A convenient scale was selected and an arc was drawn to represent the centerline of the curved taxiway under analysis.
2. The position of the specific light under analysis was plotted.
3. A line was drawn from the pilot's eyes to the light and the angle between this line and the center of perspective line was measured. This was the angle to the right (in this case) of the center of perspective.

FIG. 5-2. Finding the angle right of center.

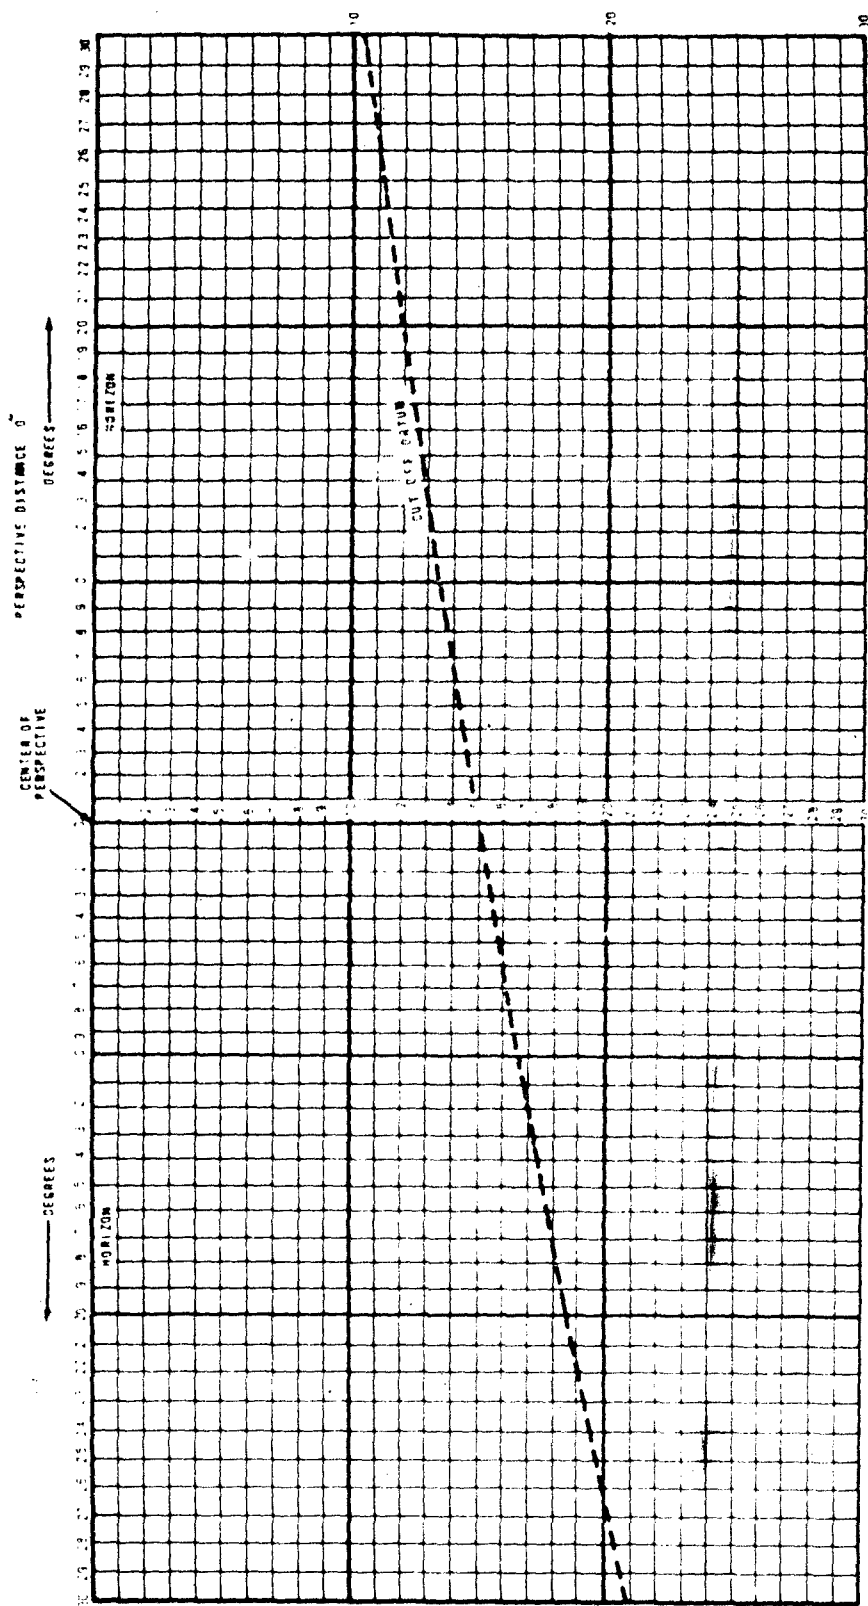
FIG. 5-3 THE PERSPECTIVE DIAGRAM GRID (REDUCED FROM
11 1/2" x 5 3/4")
